# Corrosion of Roof Truss Connector Plates in Farm Buildings

## Factsheet

FACTSHEET 16-041 AGDEX 714 AUGUST 2016

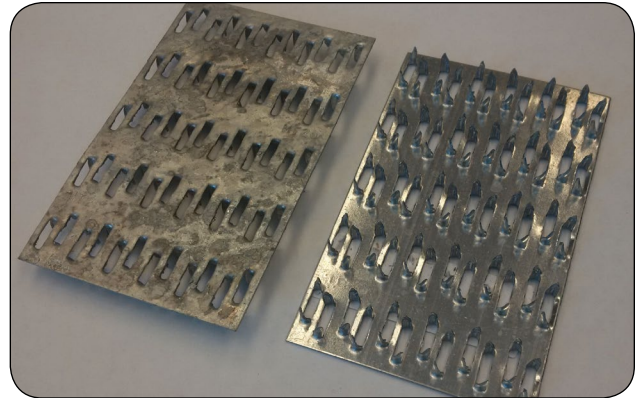
**Figure 1.** Example roof truss connector plates. The plate on the right was fabricated from galvanized sheet steel. The plate on the left was galvanized after plate fabrication.

Some additional protection for limited corrosive environments is provided by using plates with Coating Designation G185. The designer should check with the plate manufacturer or truss supplier to ensure these plates are available and the level of corrosion resistance provided. Since the punching process to fabricate the plates also exposes unprotected edges of the teeth, insist on hot-dip galvanizing the plates after fabrication.

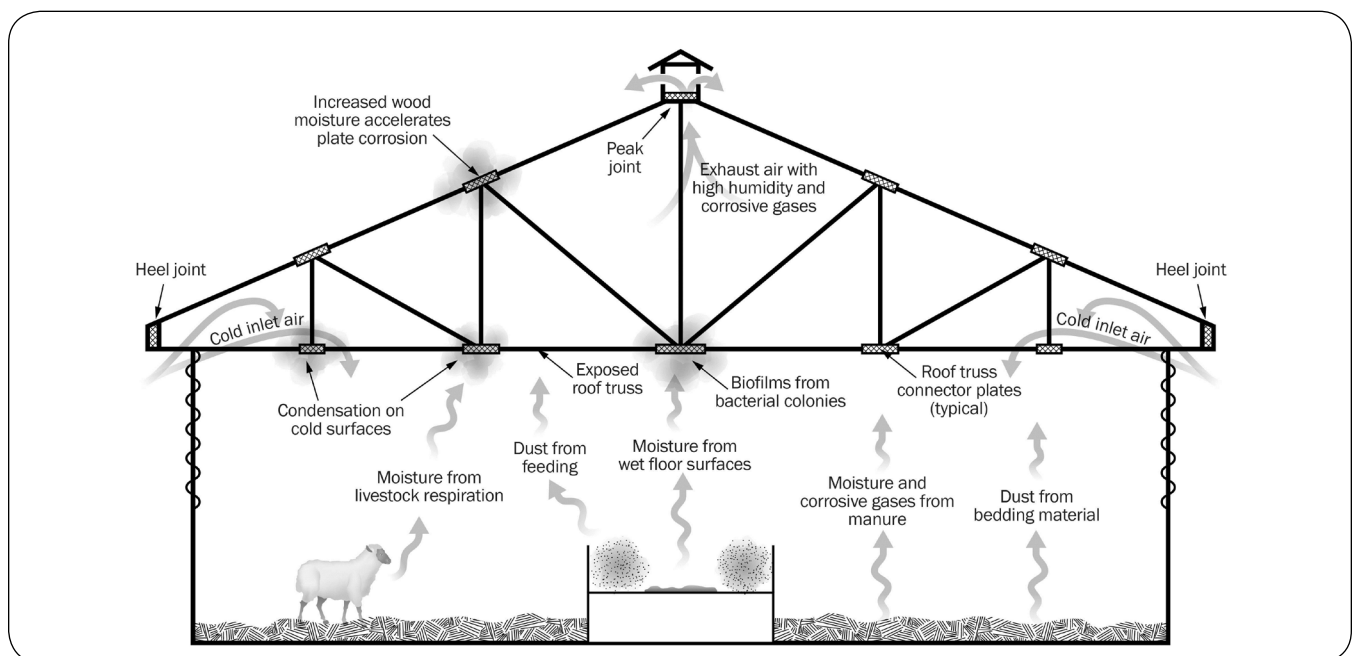
Livestock barns and roofed manure storages without ceilings are often affected by corrosion. These buildings allow moisture, corrosive gases and dust direct access to the trusses and connector plates (Figure 2). The connector plates often show the greatest deterioration near the building air exchange openings, at the heel and peak joints of the truss. These are the areas of significant air mixing and temperature changes, coupled with high humidity and corrosive gas concentrations, producing ideal conditions for corrosion. The heel and peak joints are critical to the structural integrity of the trusses.

**Figure 2.** Sources of moisture, corrosive agents and dust that cause corrosion. This barn has no ceiling, allowing contaminants direct access to the truss and connector plates.

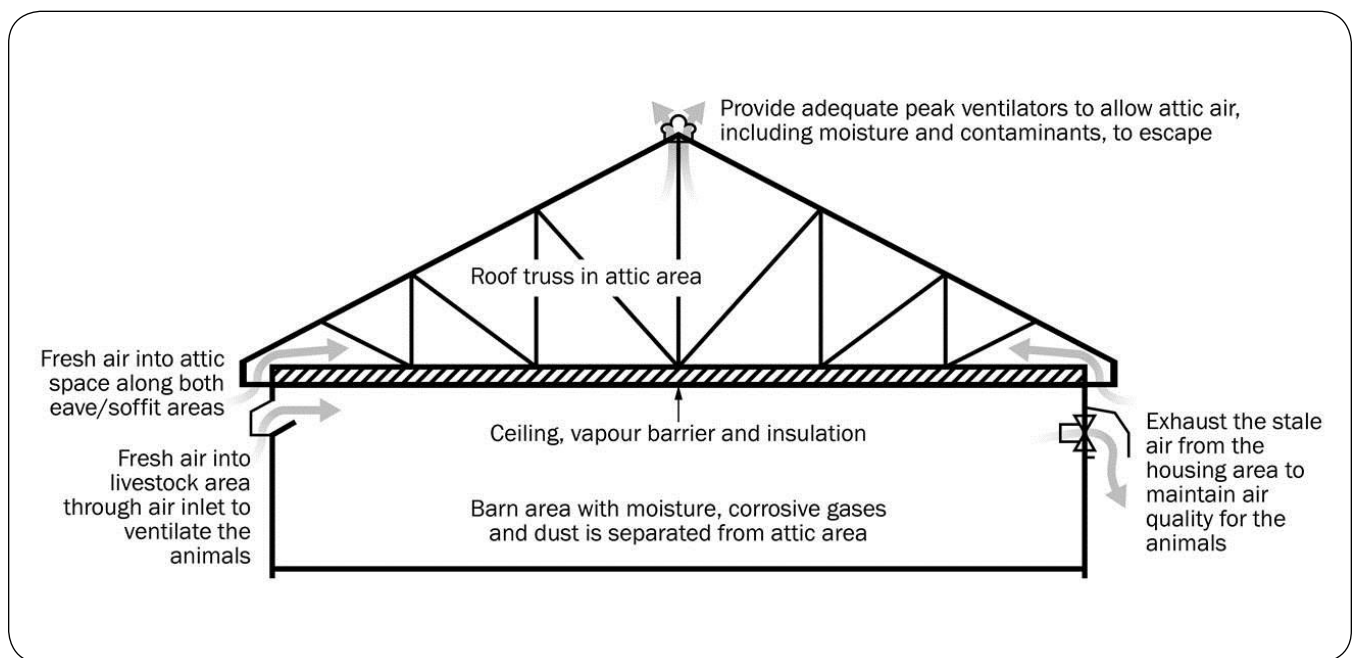
**Figure 3.** Building sketch showing the roof truss assembly completely separate from the barn area by a ceiling, vapour barrier and insulation. Note the attic ventilation and well-designed barn area ventilation system.

If the truss assembly is completely separated from the livestock environment, as shown in Figure 3, it will not be influenced by the moisture, corrosive agents and dusty conditions that cause corrosion. A minimum 6-mil polyethylene vapour barrier with the seams taped will limit moisture migration into the attic space. Typical steel or plywood ceilings by themselves do not provide an adequate vapour barrier — the sheet seams,

Ventilate the attic area to allow moisture to escape and allow fresh air to enter along both the eave and soffit areas. The building in Figure 3 uses vented soffit at the eaves and chimneys at the peak to ventilate the attic space. Note that in fan ventilated facilities with attic/ceiling air inlets, the minimum ventilation rates must be sufficient to ensure warm, moist inside air is not drawn into the attic space through the room inlets. For more information, see the Ontario Ministry of Agriculture, Food and Rural Affairs Publication 833, *Ventilation for Livestock and Poultry Facilities*, and consult a designer or builder for the appropriate number and sizing of components.
